NRL Memorandum Report 656

TANKAGE FAILURES OF AEROBEE-HI AND VANGUARD ROCKETS

J. E. Srawley
METALLURGY DIVISION

December 1956

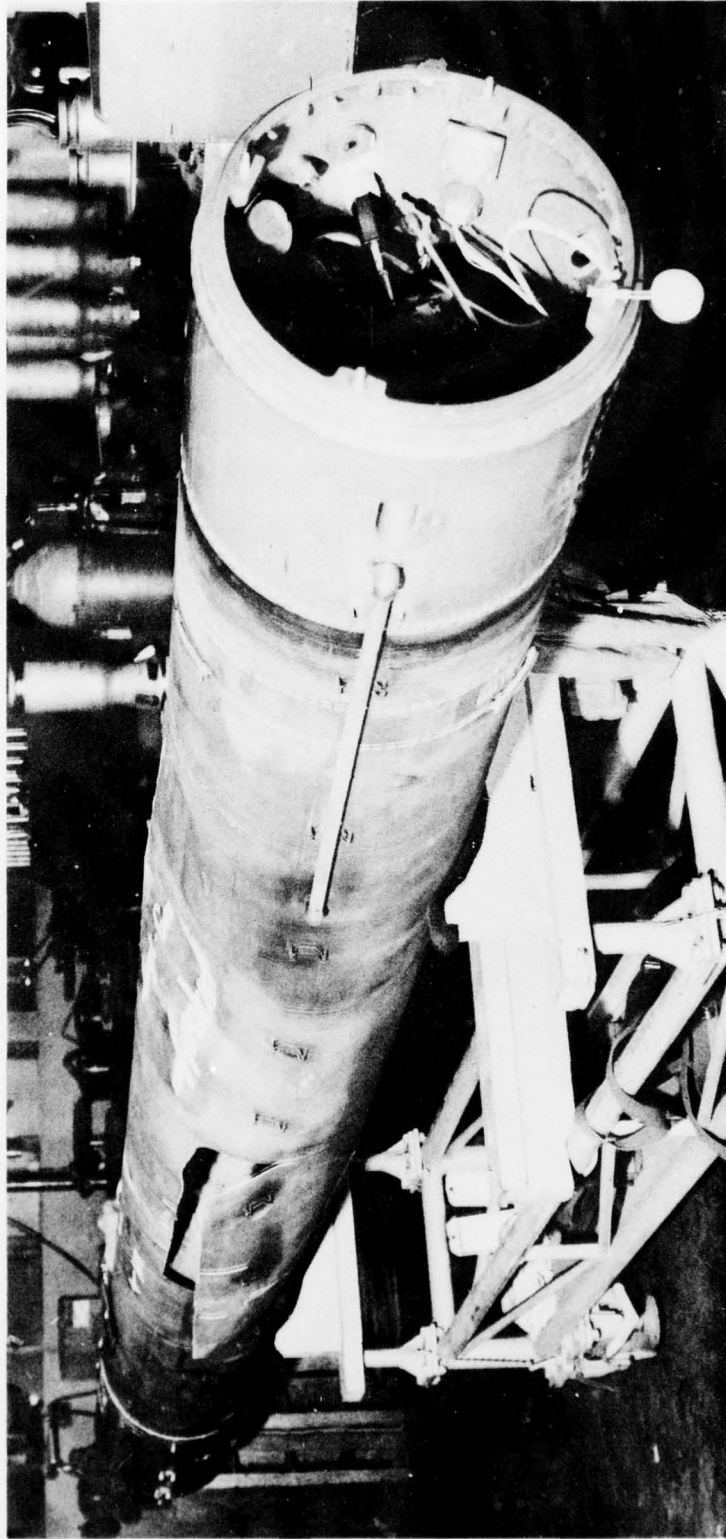
At Fort Churchill pressure was applied to the oxidizer tank hydrostatically while the rocket was resting horizontally in a suitable fixture. At approximately 520 psig pressure, corresponding to a calculated maximum principal tensile stress of 121,000 psig, the tank burst longitudinally along weld #L4. Figure 3 is a view of the whole rocket from the forward end showing the location of the failure. Figure 4 shows the burst section in more detail, while Figure 5 is a close up of the central section of the fracture.

Figure 3 - View of Aerobee - Hi NRL #48 from forward end showing burst oxidizer tank

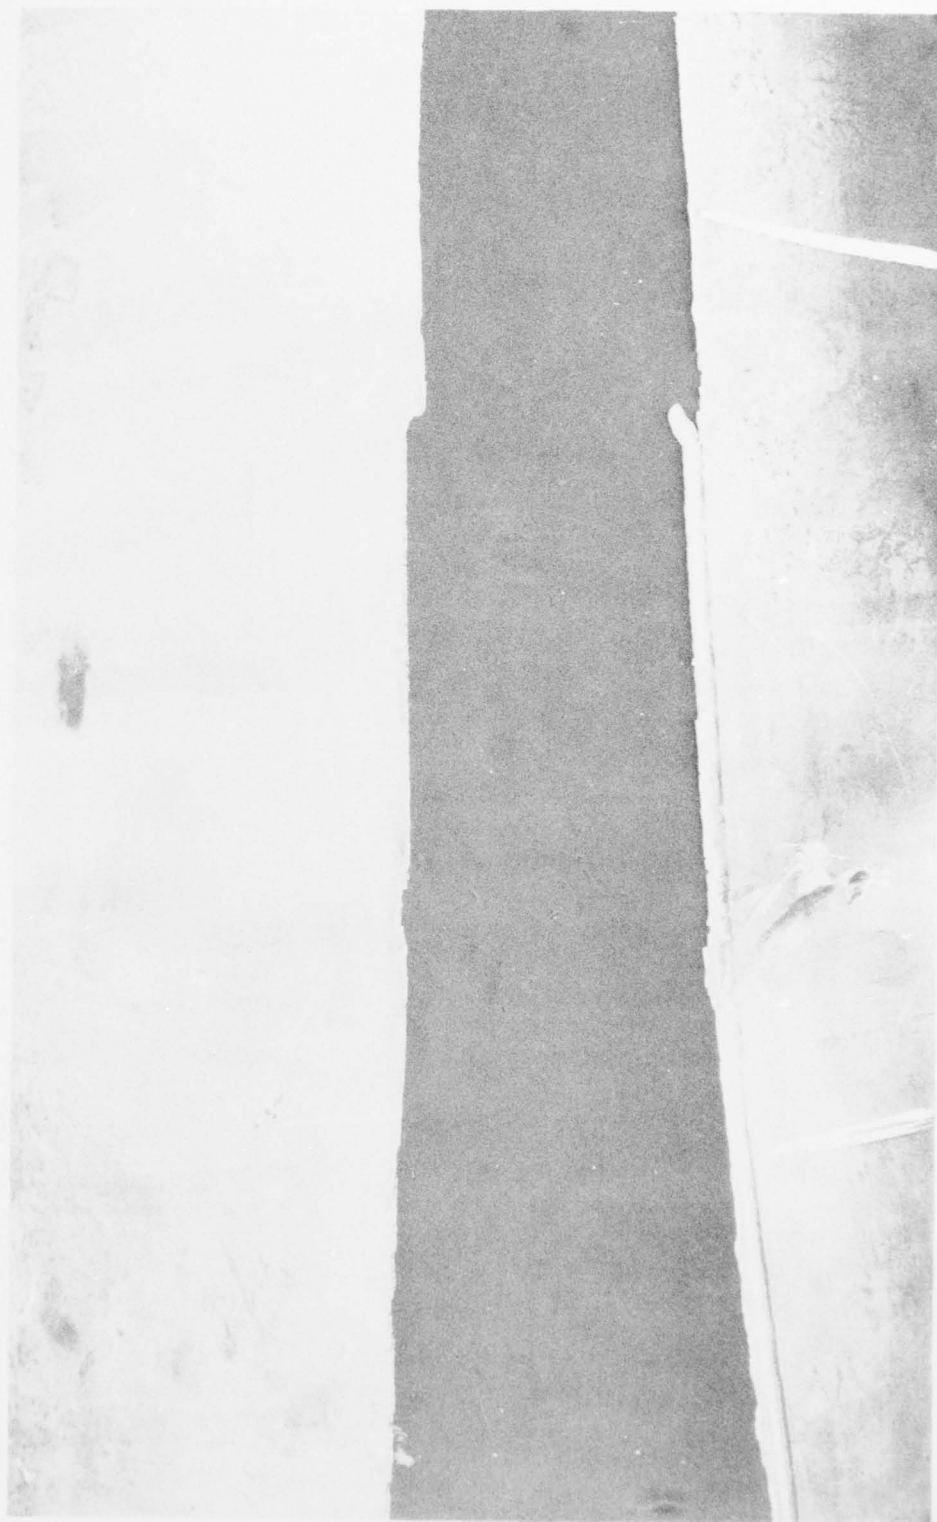
Examination of the fractured pieces shows that the run of the upper fracture through the weld follows the end of a length of repair weld. This repair weld can be distinguished in Figure 5 by its irregularity compared with the automatic weld aft of it. Forward of the crossing fracture, there is about an inch of automatic weld and then a further length of hand repair weld. The presence of these lengths of hand repair welding in the locality of the presumed origin of fracture arouses suspicion and they were therefore scrutinized. The back of the welds was characterized by considerable drop through of weld metal and by undercutting of more or less severity at the junction of the drop through and the parent metal. This is illustrated in Figure 6. Figure 7 is a photomicrograph of a typical section through the

Figure 5 - Close-up view of Fracture in Oxidizer Tank
of NRL #48

This is, in fact, what A. Co. propose to do. While the previous specification allowed hand repair welds at the discretion of the inspector examining the radiographs, such repairs will now be allowed only on the action of the Material Review Board consisting of two representatives from A. Co. and a Bureau of Aeronautics representative. This will certainly result in more rejections of tankages in process, and ultimately in improved quality of welding. In view of the seriousness with which the failure is regarded at A. Co. it is also likely that everyone concerned will regard the welds with more suspicion than hitherto.

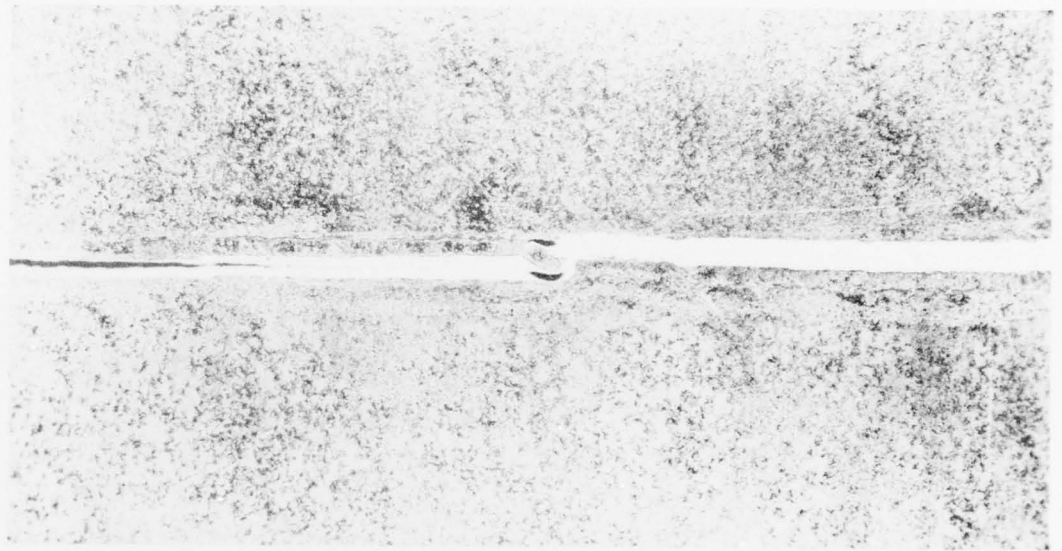
Figure 6 - View of Back of Central part of the Fracture in the Oxidizer Tank of NRL #48

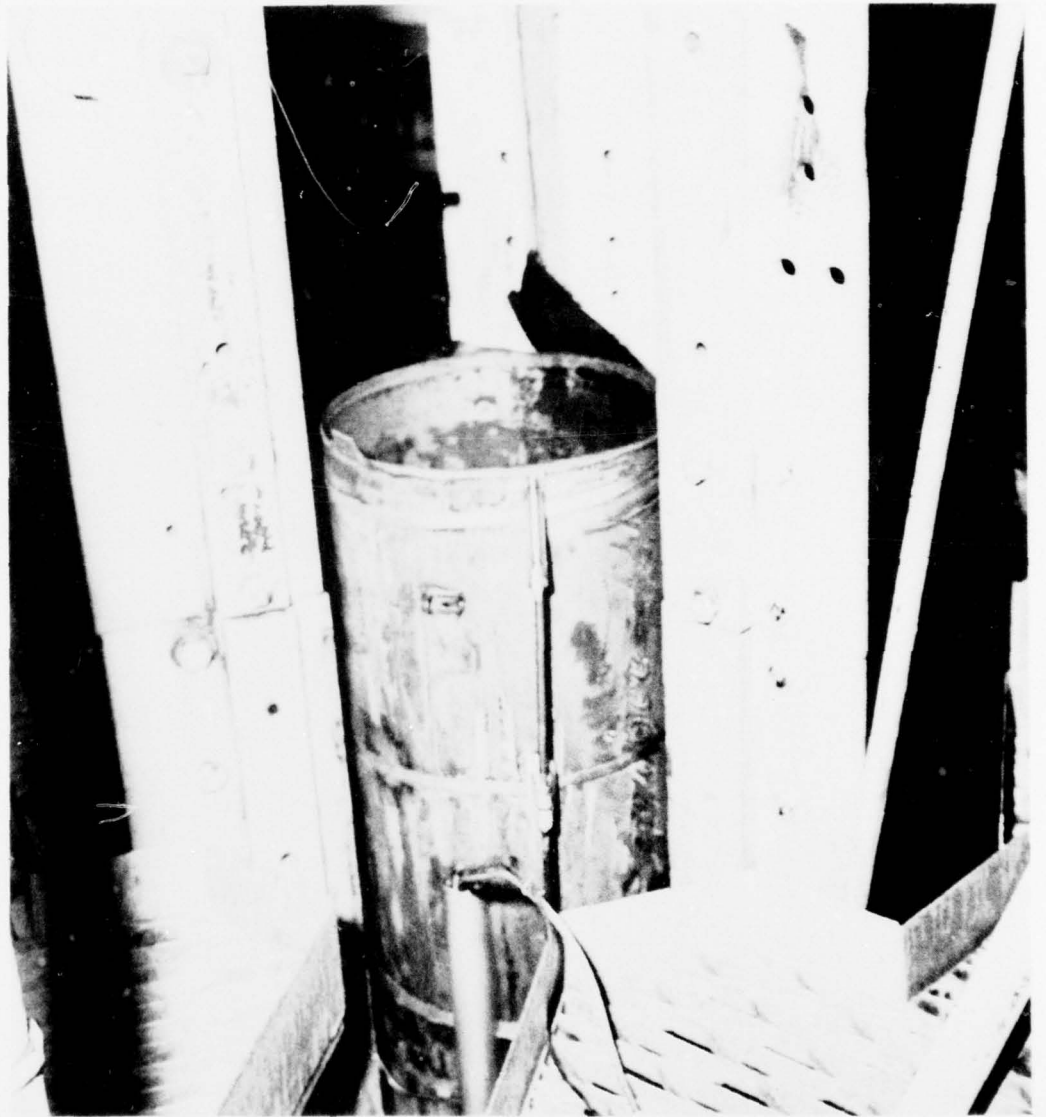
The failure was violent, the whole helium tank, together with the instrumentation section on top of it, being neatly separated from the oxidizer tank, while at the same time the lower hemispherical dome of the helium tank separated into five pieces which were projected violently away from the rocket. Two of them were found embedded in the walls of the building. Figures 8 to 11 illustrate the features of the damage.

Figure 8 - View of Top of Oxidizer Tank of NRL #45 after separation of Helium Tank

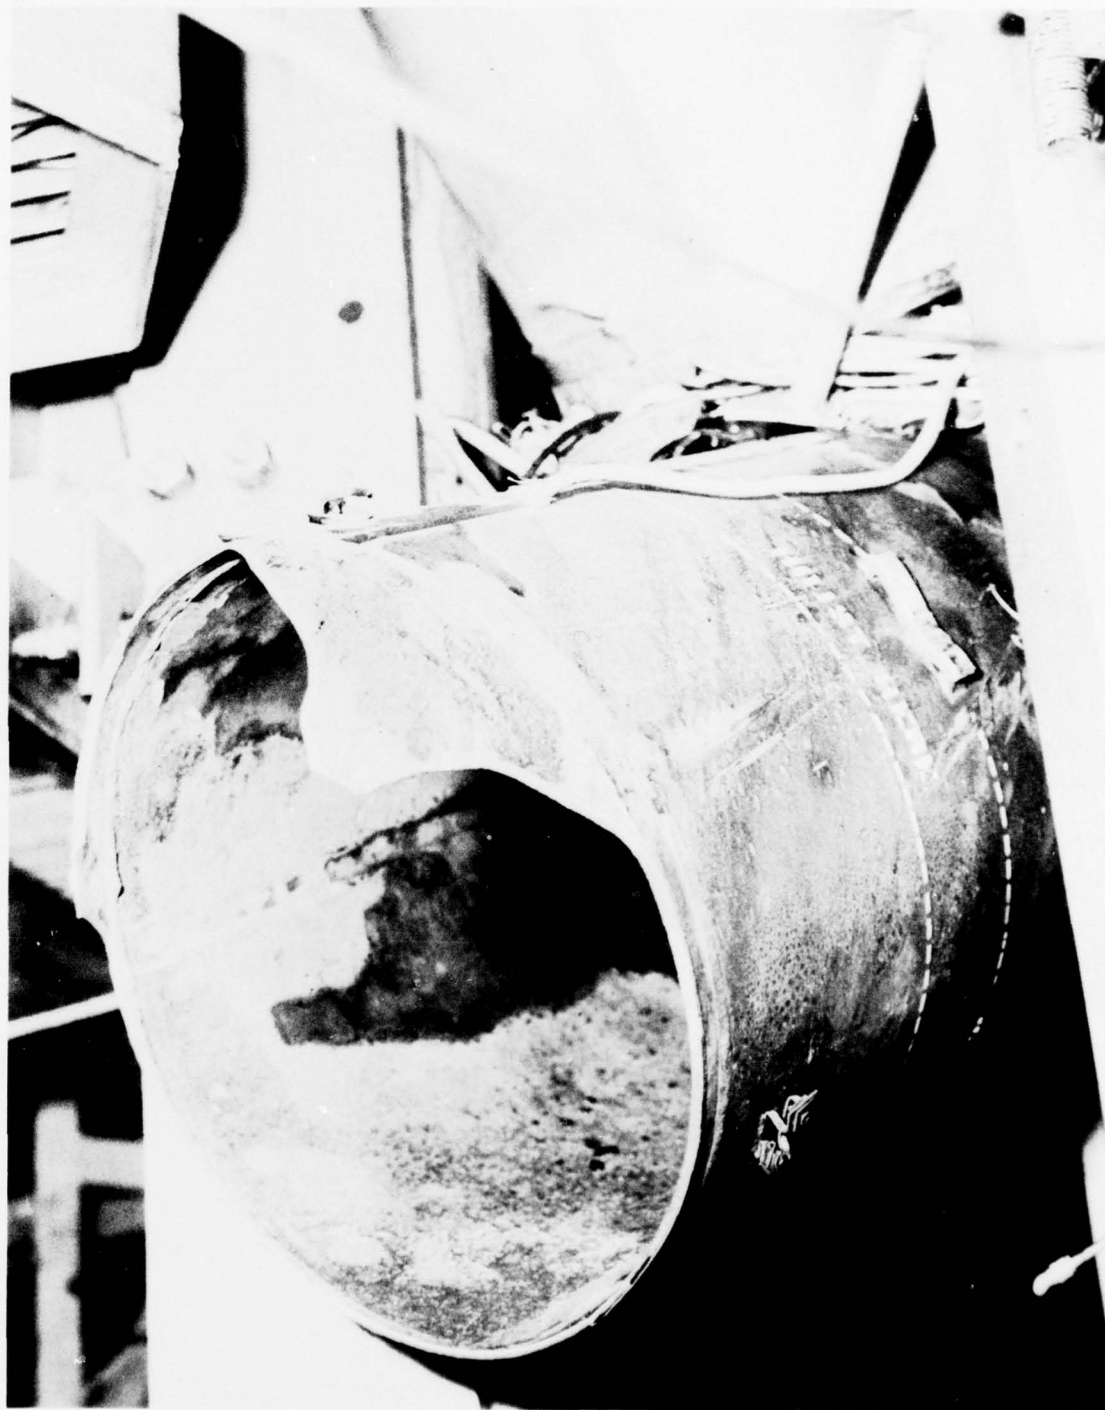
Part of the dome did not separate from the helium tank. In Figure 12 this is located along the arc CDEF, reference to Figures 9, 10 and 11 will help visualization. At D the fracture surface is several inches from the rim of the dome. From D it runs down on either side to the weld joining

Figure 9 - View of fractured end of Helium Tank in position in which it was found after Failure of NRL #45

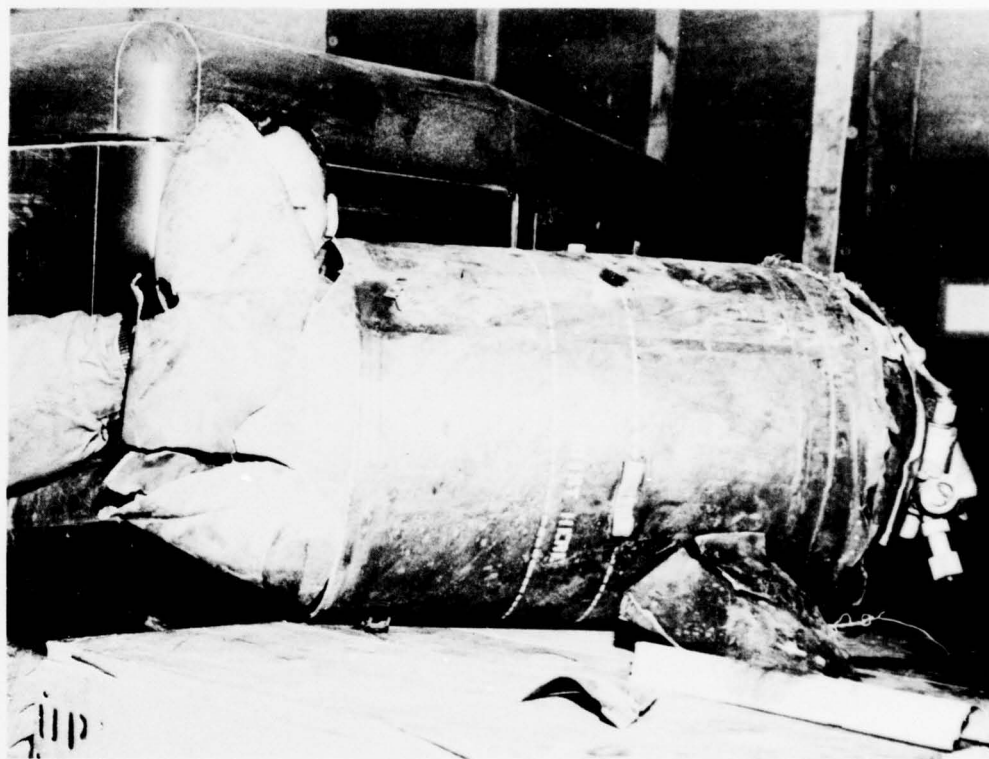
Figure 10 - View of Helium Tank of NRL #45 after removal from Launching Structure showing two separated pieces being held in position and two other pieces in foreground

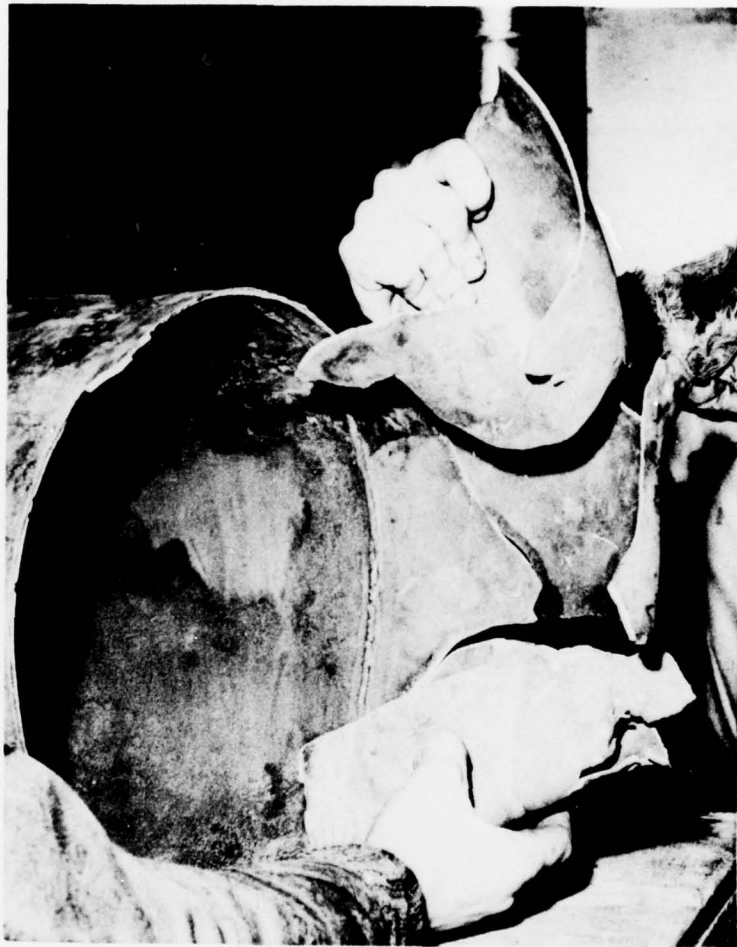
Figure 11 - Another view of the Fractured End of the Helium Tank with
two of the separated pieces

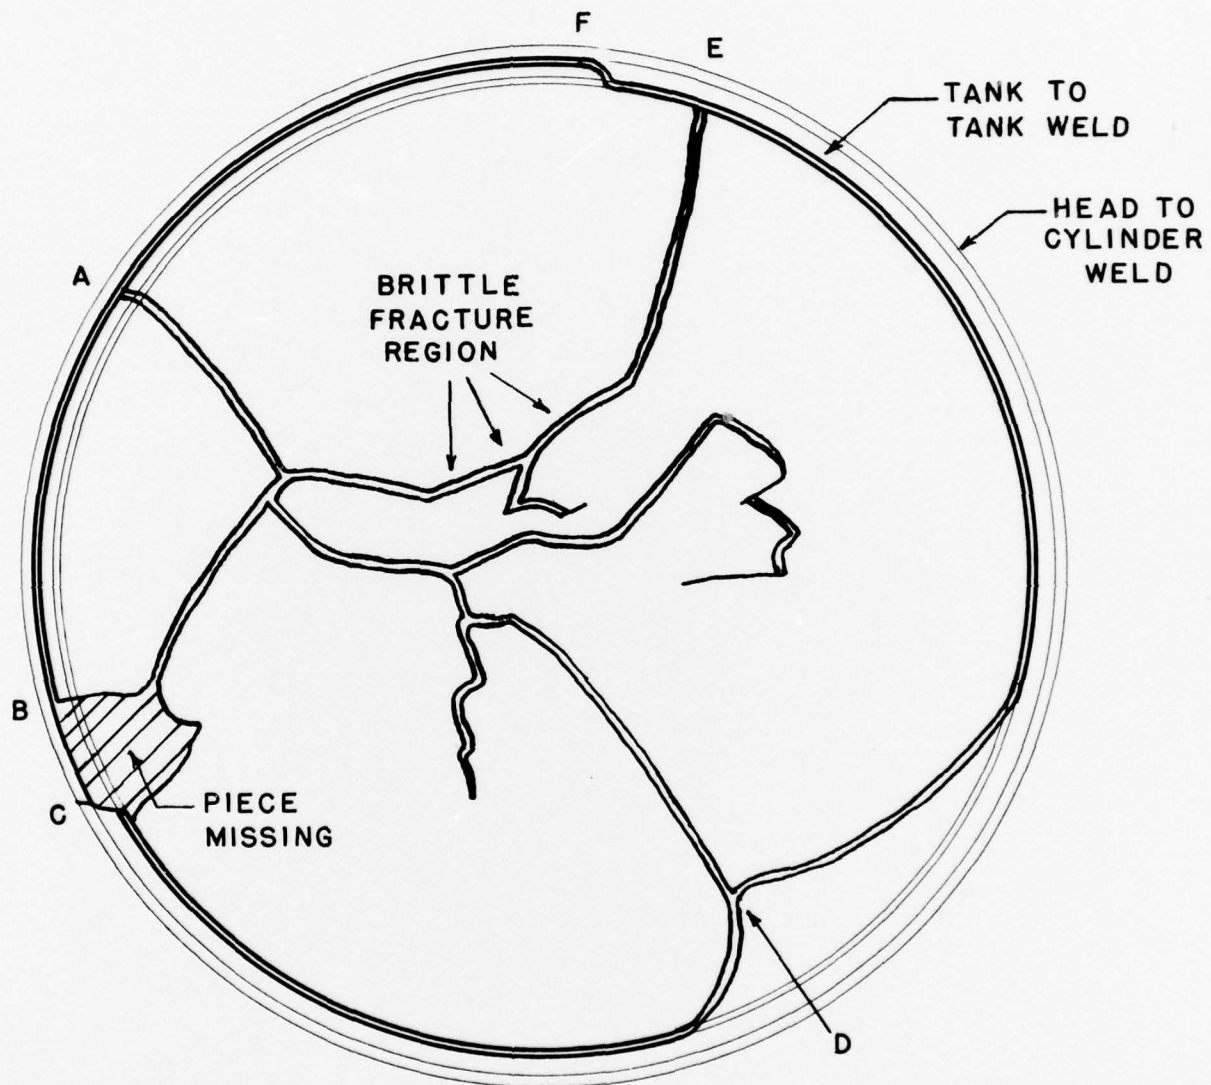
Although the recovered pieces of the dome were too badly distorted to be fitted together for photographing, it was nevertheless possible to match the fracture surfaces. An attempt has been made in Figure 12 to sketch schematically the principal fractures in the form of an end-on view of the tank. While this sketch is not accurate in detail it is considered to be accurate in the important features. It will be noticed that one of the five pieces which separated was not recovered.

Figure 12 - Schematic Reconstruction of Fractured Hemispherical Dome of Aerobee - Hi Helium Tank

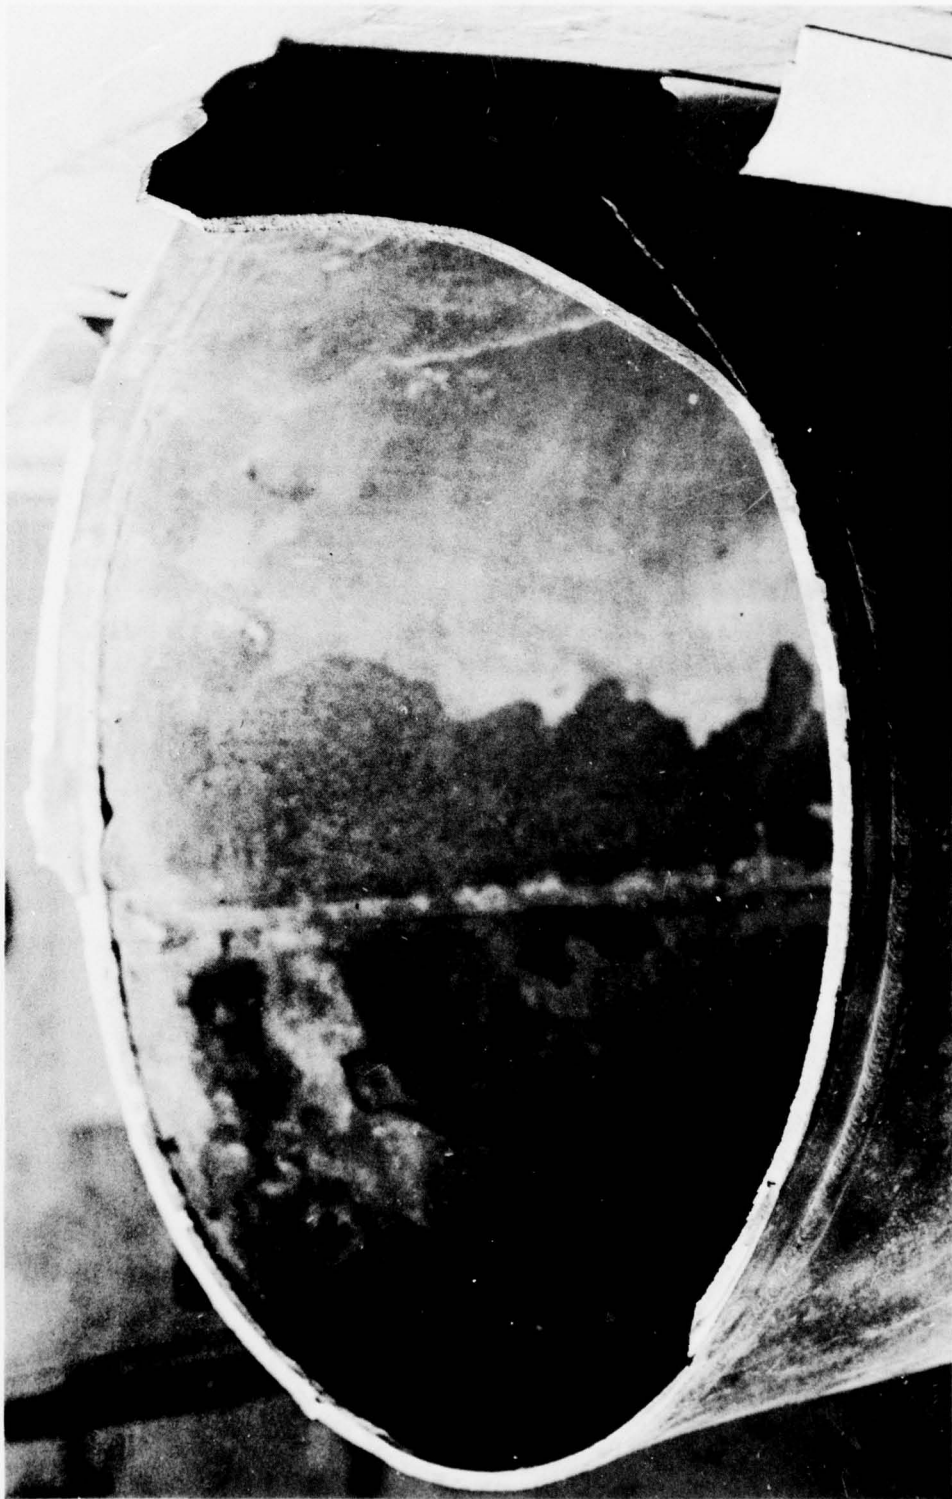
the helium tank to the oxidizer tank and follows this weld in both directions to the points C and F. At these points it crosses to the weld joining the dome to the body of the helium tank and follows this weld along the arc CBAF. Near A is a noticeable discontinuity where a fracture running from C towards F might have met one running from F towards C. All of this fracture surface is of the oblique shear type. These features can also be seen in Figure 13 which is a close-up view of this fracture surface.

Figure 13 - Close-up view of fractured surface of Helium Tank

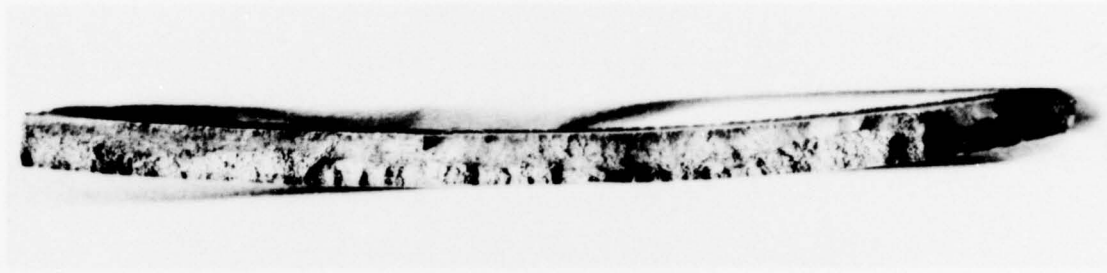
were characterized by granular fracture normal to the convex surface (i.e., the surface in contact with the acid), continuing part way through the section, and completed by the usual shear fracture to the inner concave surface. These features are clearly shown in Figure 14.

In view of the various circumstances: (1) sudden fracture under constant stress after sustaining the stress for some time, (2) contact with acid under stress, (3) short sections of granular fracture normal to the surface surrounded by oblique shear fracture, the most likely cause of initiation of fracture is stress-corrosion cracking. Microscopic examination confirmed the presence of typical intergranular stress corrosion cracks in the vicinity of the granular fractures. Such a crack is shown in Figure 15 which is a photomicrograph taken from a microsection normal to the dome of the tank near an area of granular fracture. Such cracks were found frequently on the convex surface, which had been in contact with the acid, in each of several microspecimens examined. No cracks were found on the concave surface which had not been in contact with the acid.

Figure 14 - Section of NRL #45 Dome Fracture showing Stress Corrosion Fracture on the acid side (bottom) and Shear Fracture on the Helium Side (top). 2X (Approx)

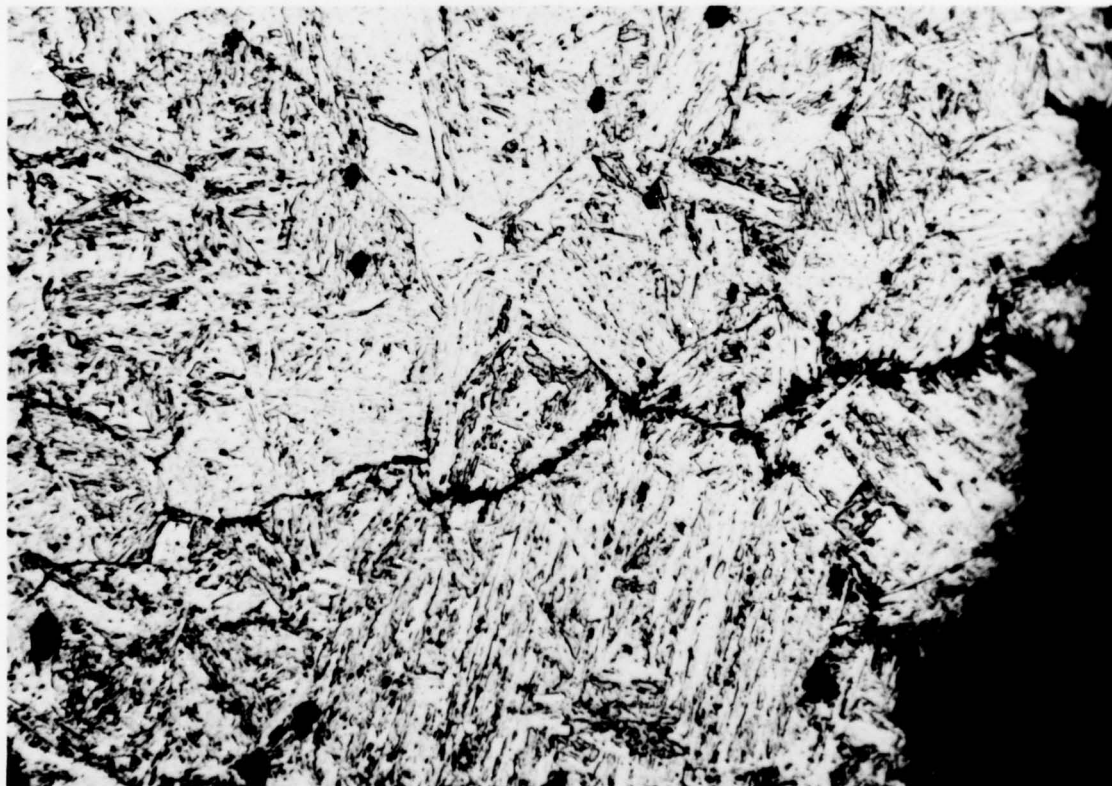
The evidence is therefore completely in accordance with the hypothesis of initiation of the failure by stress-corrosion cracking. A. Co. Materials Engineers have stated their concurrence in this diagnosis.

Figure 15 - Photomicrograph of stress corrosion crack in the vicinity of the Fracture shown in Figure 14. 1000 X, Etched Picral/HCl

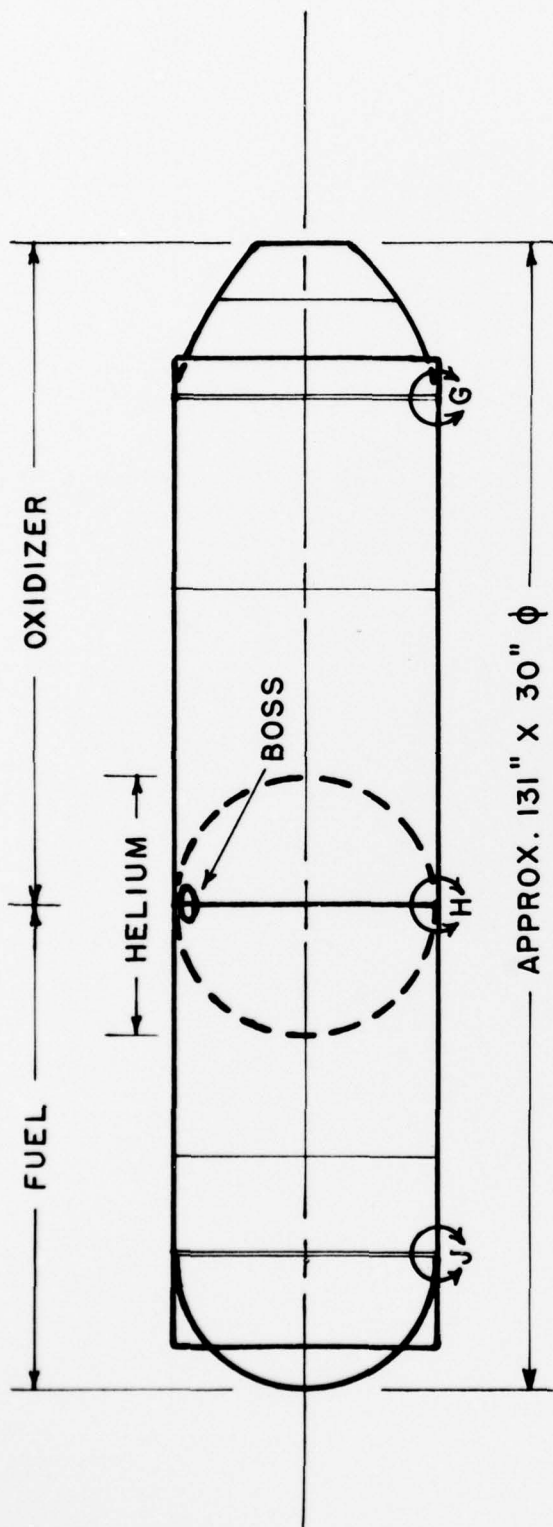
Figure 16 - Schematic of Vanguard Tank Assembly Showing Locations of Girth Welds only

The first failure was a fracture of a helium sphere which originated at the boss shown in Figure 16. This boss is normally a type 410 stainless steel forging. In the case under consideration, a type 431 stainless steel boss, machined from bar stock, had been substituted because of procurement difficulties (the tank was intended only for test purposes). This boss did not have the structure or grain flow necessary to sustain the stresses and therefore split into four pieces at 1565 psig during pressure testing. These fractures propagated into the helium sphere a short distance and then terminated. Recurrence of this type of failure is not to be expected since no further spheres will be fitted with type 431 bosses. Subsequent proof testing of other spheres has demonstrated the ability of type 410 bosses to sustain the stresses (which are lower than in the actual tankage).

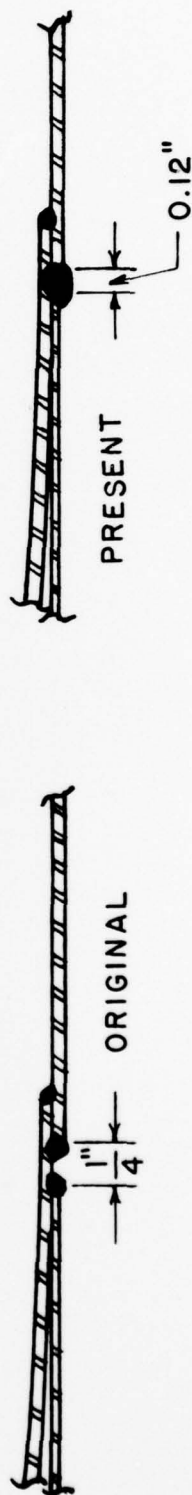
The second failure occurred to the fuel tank of a unit having a head to body weld of the original type shown in Figure 17. The head blew off at 390 psig, the fracture running between the two welds shown in the Figure, joining head to body and skirt to head, sometimes along the edge of one weld and sometimes along the edge of the other. It was thought to be a weld-associated failure and, as a consequence, the joint design was changed. The first modification was to bring the two welds closer together and then fuse them with a third bead. The current modification consists of tack welding and then joining the three pieces with one heavier, double fillet weld as indicated in Figure 17. This joint is considered to be much more reliable than the original and, providing proper control is exercised over the welding, should not be a particular source of future trouble.

Figure 17 - Detail of Weld J (G is Similar) as Originally Designed and as Now Designed
